ENGINEERING GEOLOGY REVIEW  
INTERLAKE ROAD, APNS: 080-034-027 AND -028  
LAKE NACIMIENTO - LAKE SAN ANTONIO AREA,  
SAN LUIS OBISPO COUNTY, CALIFORNIA

PROJECT SL08247-1

May 20, 2013

**RE: Engineering Geology Review**  
Lots on Interlake Road, APN: 080-034-027 and -028  
Lake Nacimiento Area, San Luis Obispo County, California

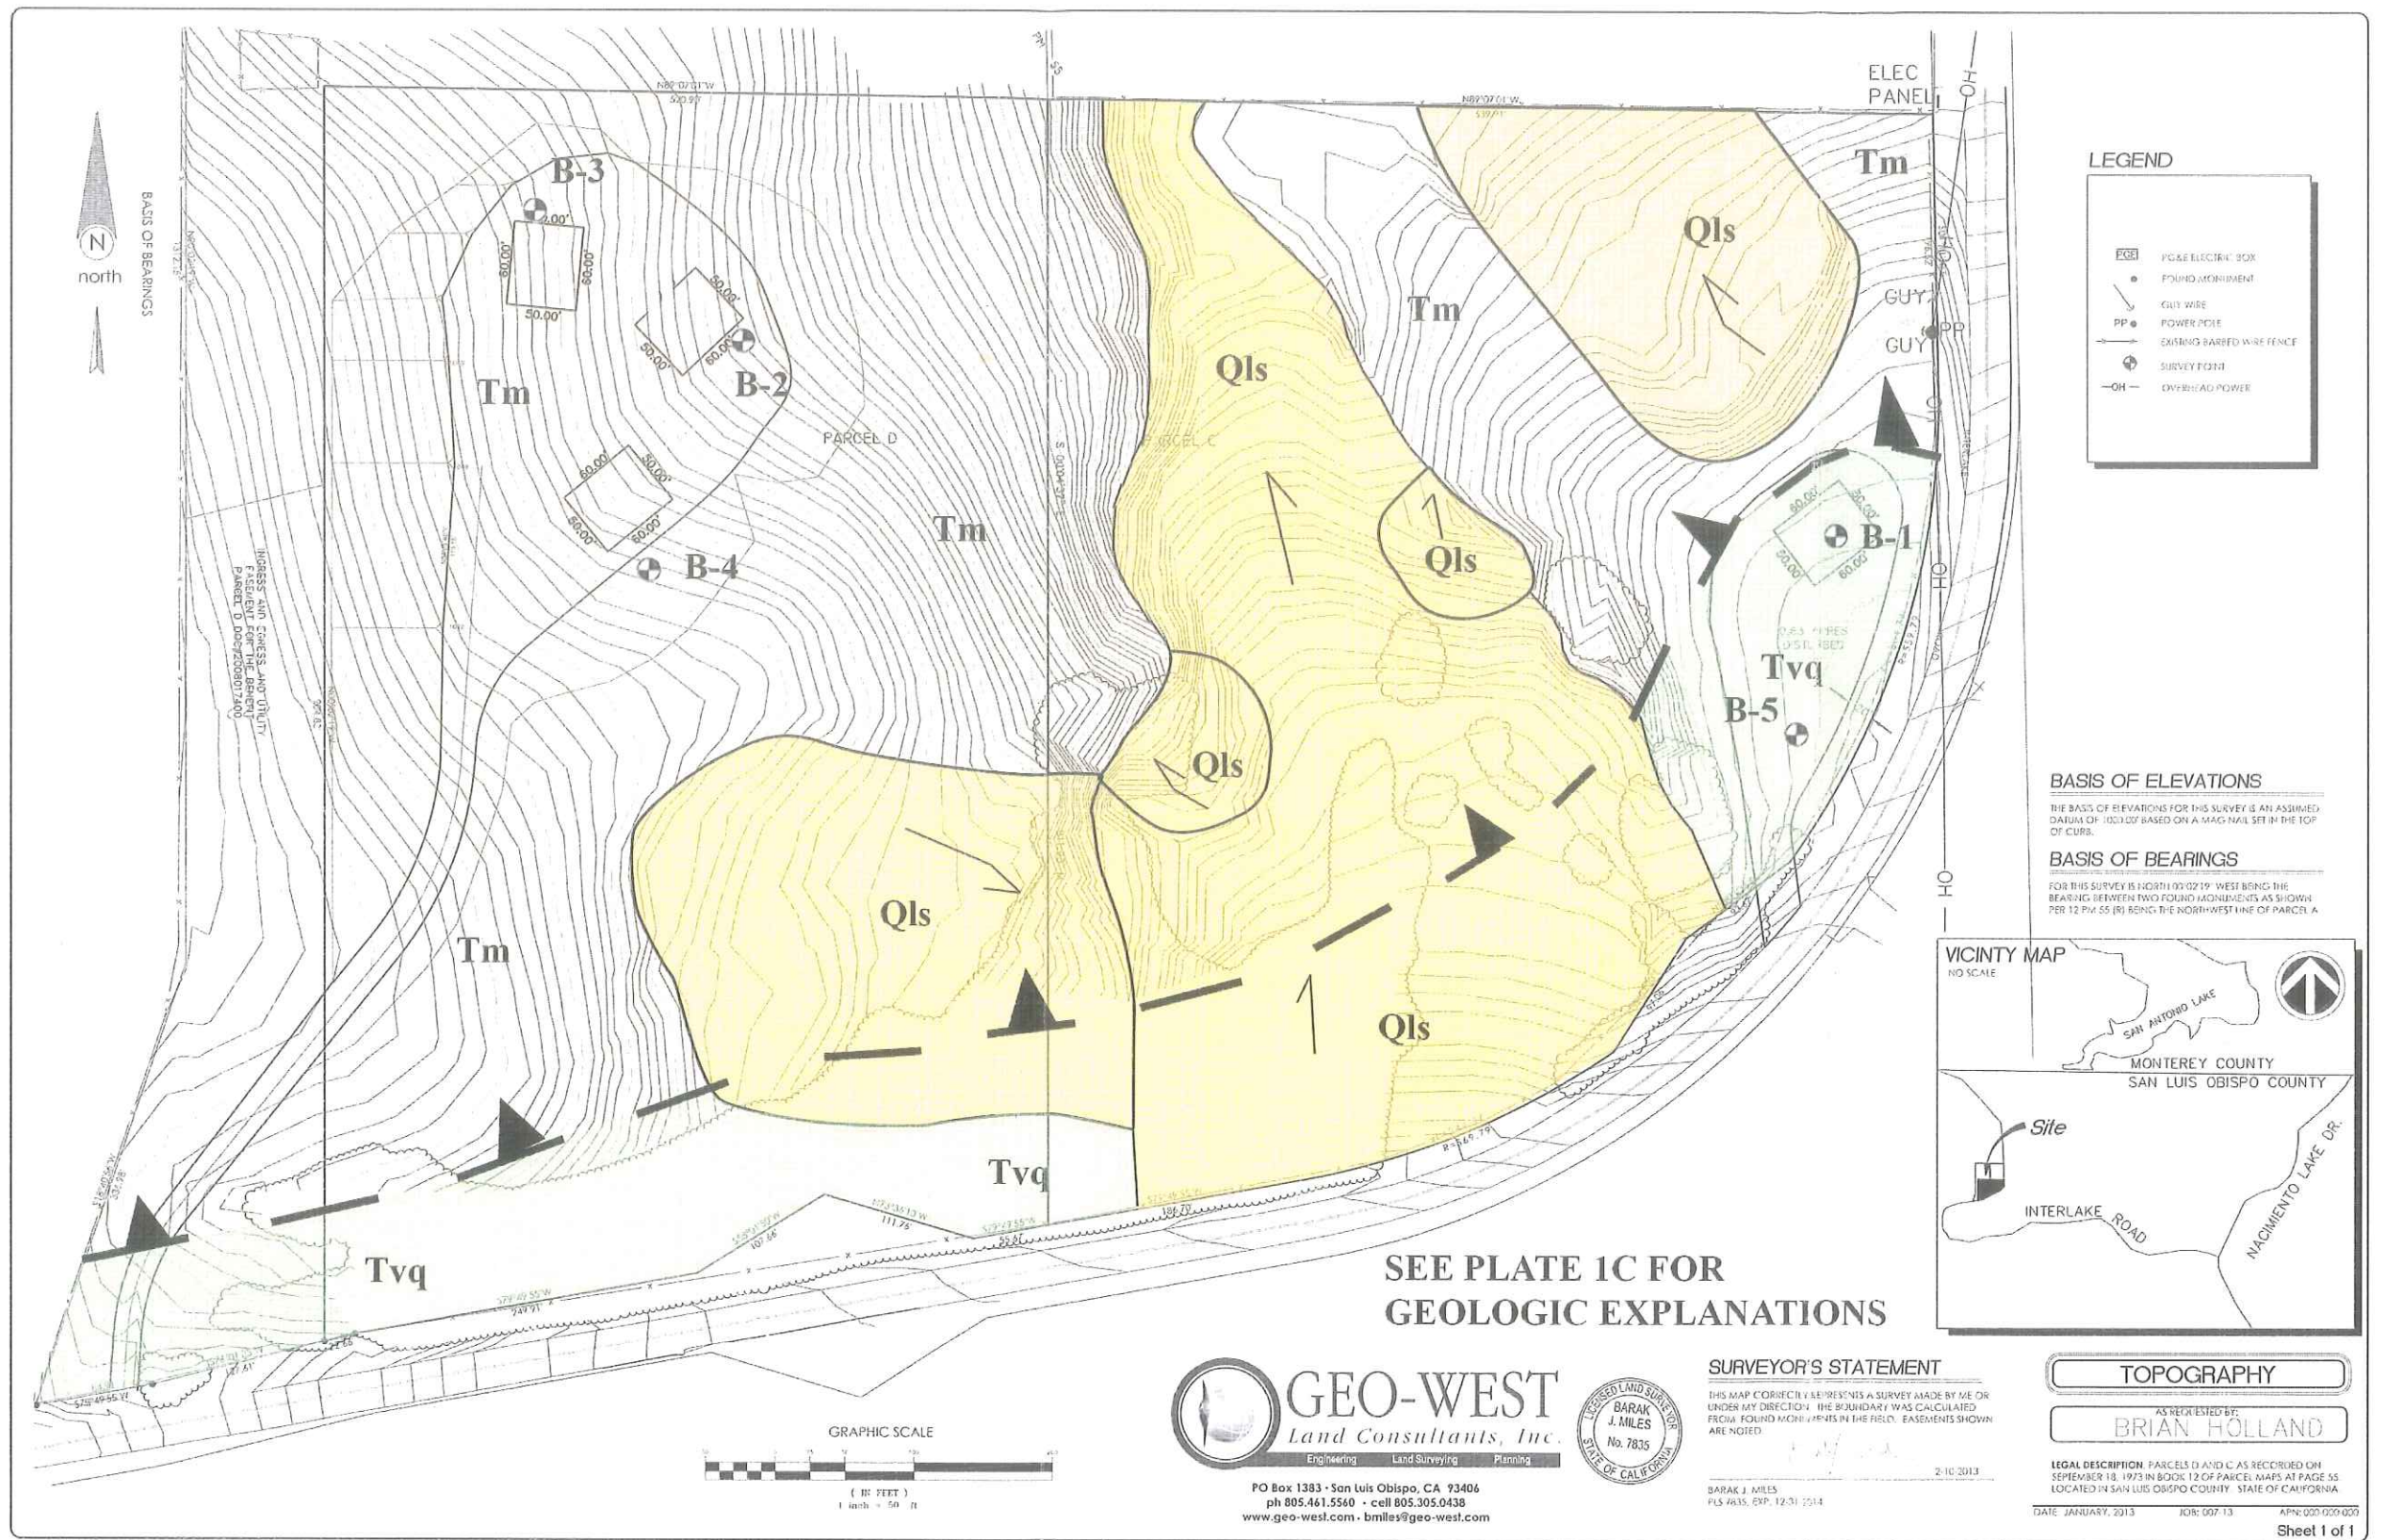
**SITE ENGINEERING GEOLOGY MAP**  
 INTERLAKE ROAD  
 LAKE NACIMIENTO AREA  
 SAN LUIS OBISPO COUNTY, CALIFORNIA

Within Boring B-1 on Parcel 028, brown clay was observed as surficial deposits along slopes of the development site and within the boring, which is interpreted as colluvium (Qc). Boring log B-1 exposed approximately 9 feet of surficial colluvium. Beneath the colluvium, Vaqueros sandstone is interpreted from 9 to 11 feet (total depth drilled). Boring B-5, drilled on parcel 028, encountered dark brown to brown sandy clay (interpreted as colluvium) from ground surface to approximately 5 feet bgs. Plate 1A and 1B depict this material as colluvium.

The San Luis Obispo County Safety Element maps the subject areas as no landslide data (Plate 10). Burch and Durham, 1970, Dibblee, 2006, Durham, 1974 and Dibblee, 1976 do not map landslides extending throughout or in the immediate vicinity of the site. Plate 9 presents the aerial photograph (Google). Landslides were mapped at the property and were observed in the aerial photograph. Plate 1A depicts the location of the landslides. Depth or character of the landslides is recommended to be investigated prior to development.

3. Subsurface investigation is recommended to investigate depth and extent of landslides at the eastern parcel (parcel 028).
4. Although the Bee Rock fault is not an active fault, it is recommended no habitable structure be placed over the fault. Development setbacks can be applied when additional subsurface information can be obtained.

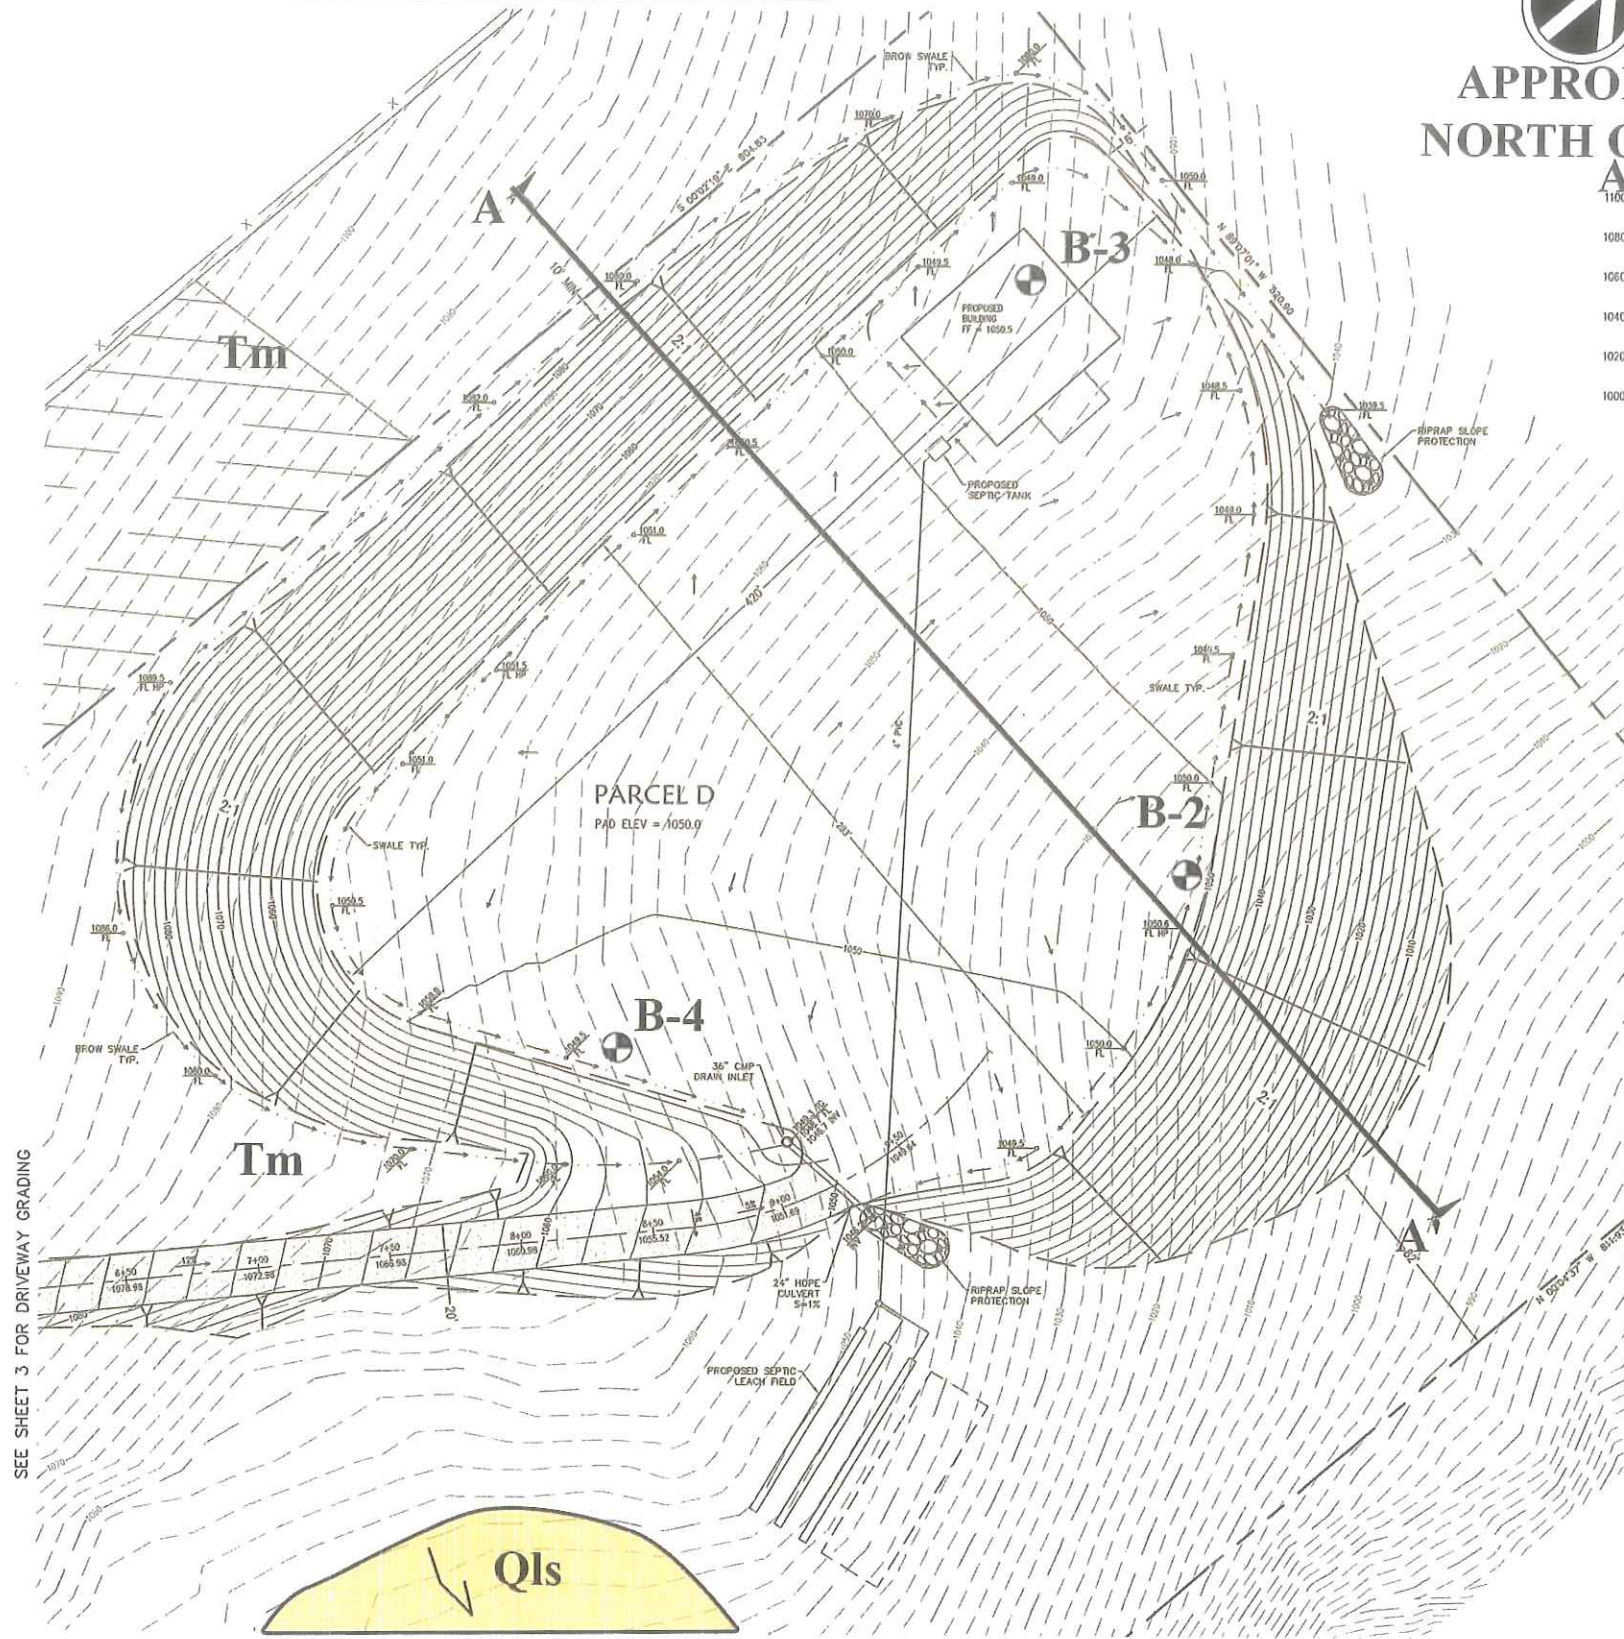
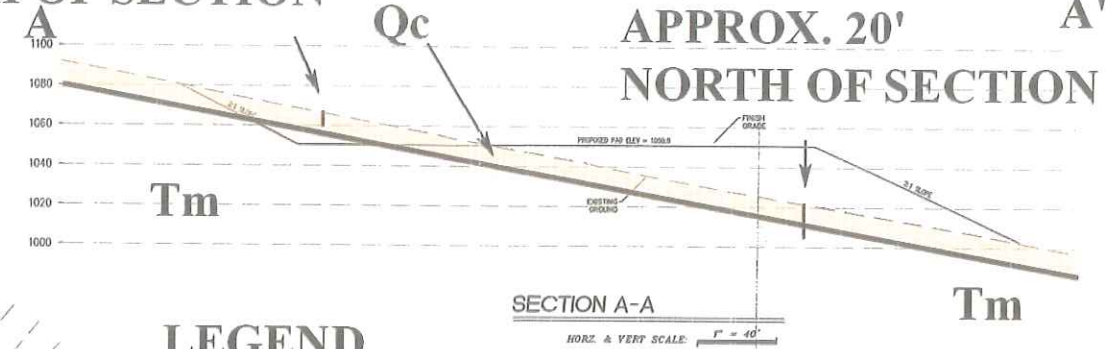
<b>GeoSolutions, Inc.</b> 220 High Street San Luis Obispo, California 93401 (805) 543-8539 fax: (805) 543-2171	<b>SITE ENGINEERING GEOLOGY MAP PARCEL 027</b>  INTERLAKE ROAD LAKE NACIMIENTO AREA SAN LUIS OBISPO COUNTY, CALIFORNIA	PLATE IC  PROJECT NO: SL08247-1
---	--	---

Septic systems for each parcel are proposed although the location for a septic field is not established on parcel 028. The septic lines proposed at parcel 027 are likely too close to landslide deposits. It is recommended that percolation testing be completed for the project and that septic fields not be established in the vicinity of landslides.

5. Septic systems are not recommended within or near landslides. Location of septic leach lines are recommended to be established on a map and the location to be reviewed by the Engineering Geologist.
