ENGINEERING GEOLOGY REVIEW  
INTERLAKE ROAD, APNS: 080-034-027 AND -028  
LAKE NACIMIENTO - LAKE SAN ANTONIO AREA,  
SAN LUIS OBISPO COUNTY, CALIFORNIA

PROJECT SL08247-1

May 20, 2013

**RE: Engineering Geology Review**  
Lots on Interlake Road, APN: 080-034-027 and -028  
Lake Nacimiento Area, San Luis Obispo County, California

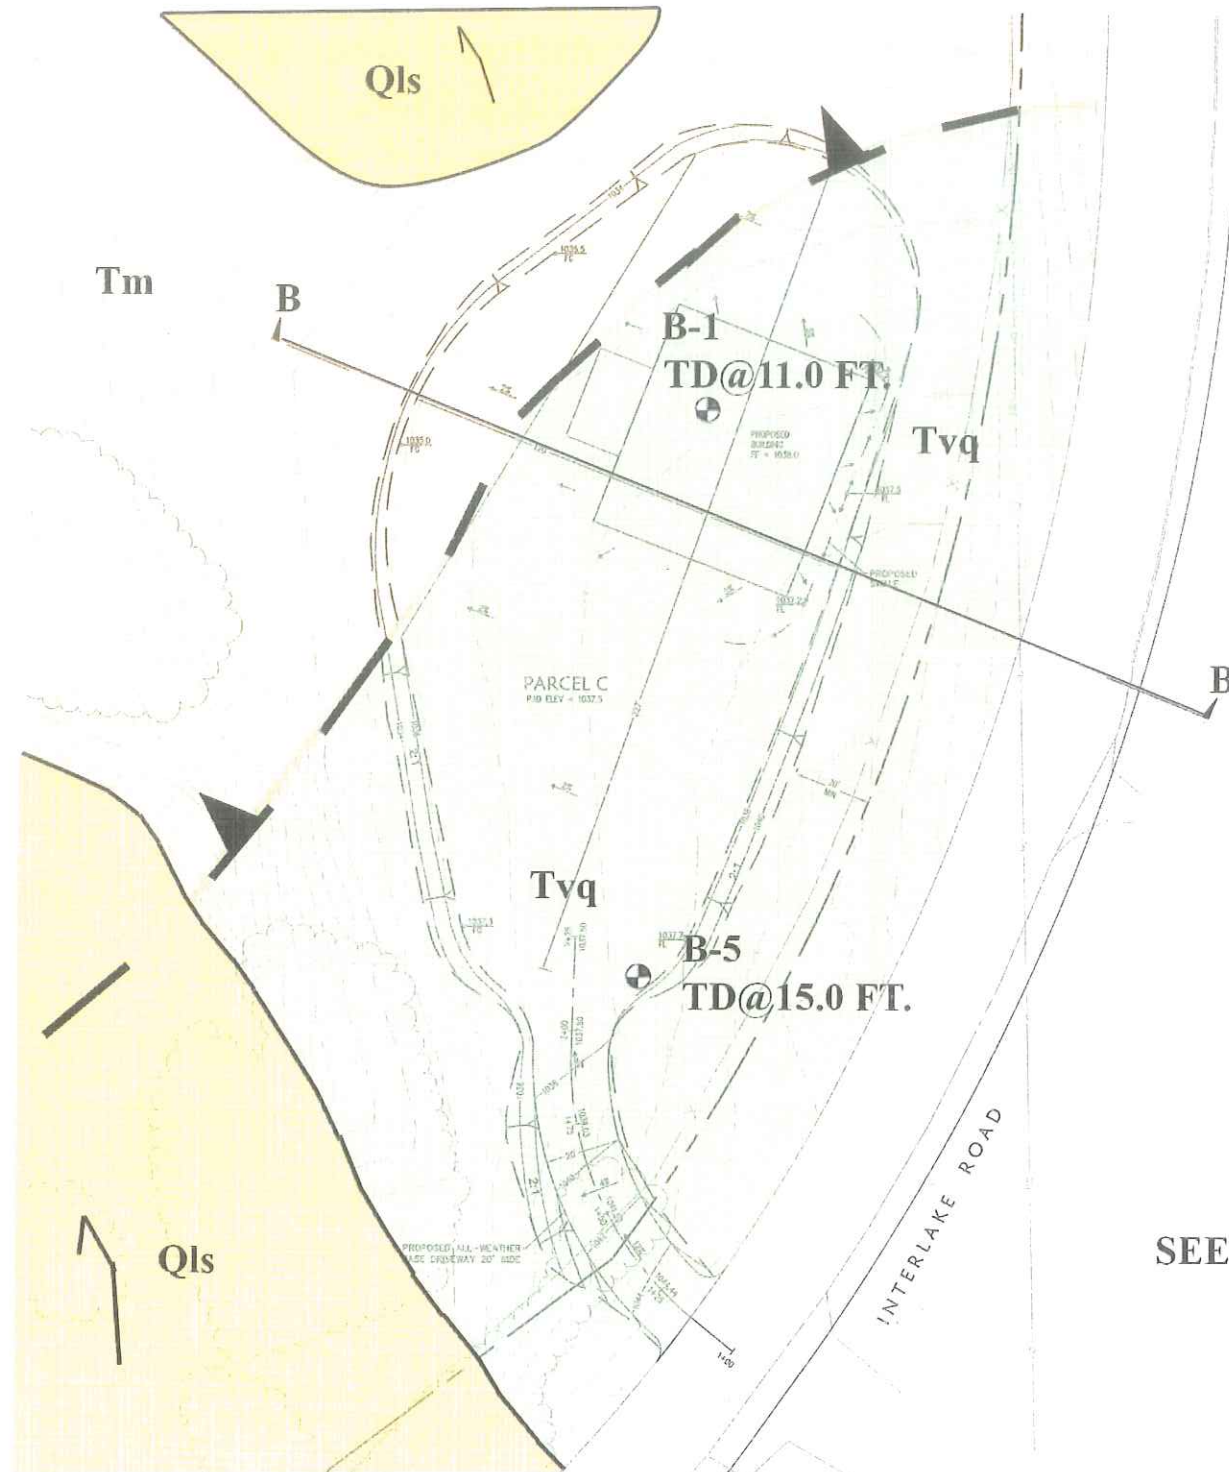
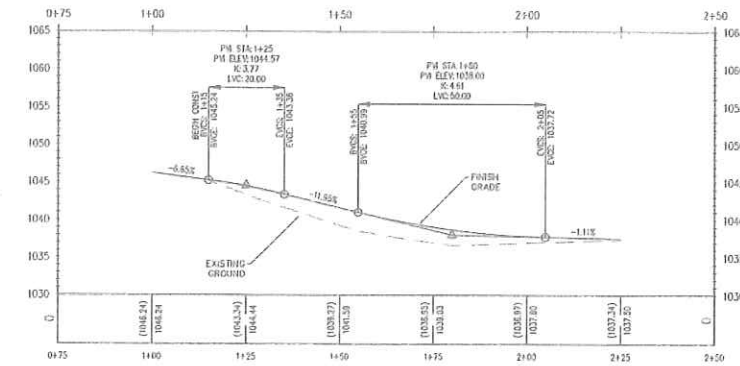
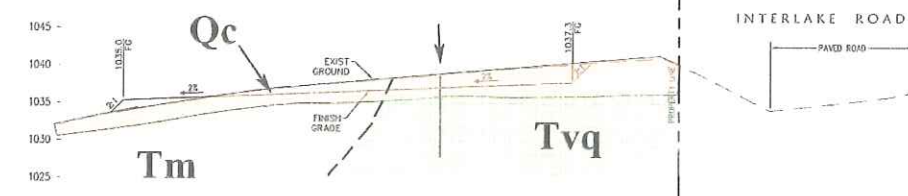
PLATE  
1B

Plates 1A, 1B, and 1C Site Engineering Geology Maps, depict the property as within Vaqueros and Monterey Formation units. A cross section is also depicted on Plates 1B and 1C through the property with assumed depths of units.

**B-1 - TD@11.0 FT.  
APPROX. 20 FEET  
B NORTH OF CROSS SECTION B'**

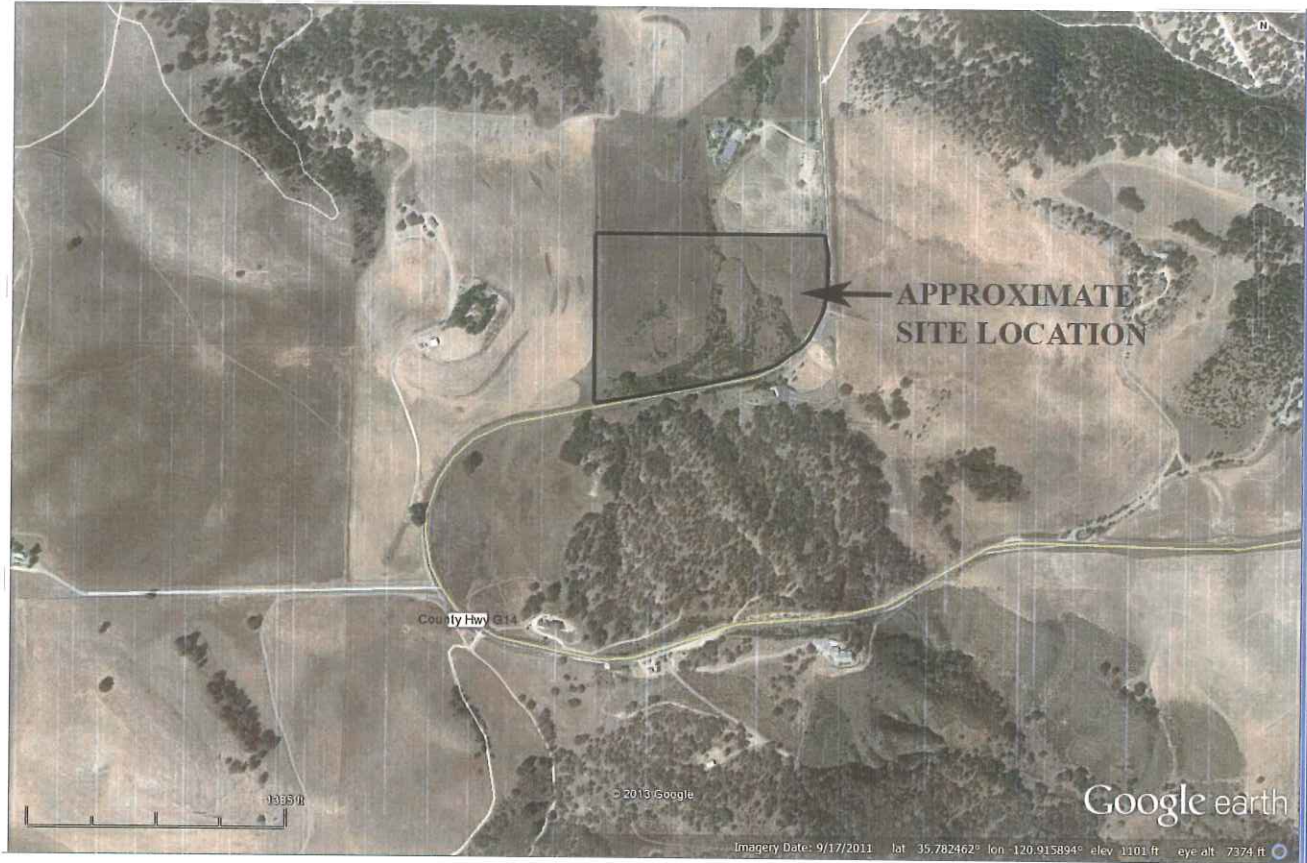
**PLATE**  
9  
**PROJECT NO:**  
SL08247-1

The San Luis Obispo County Safety Element maps the subject areas as no landslide data (Plate 10). Burch and Durham, 1970, Dibblee, 2006, Durham, 1974 and Dibblee, 1976 do not map landslides extending throughout or in the immediate vicinity of the site. Plate 9 presents the aerial photograph (Google). Landslides were mapped at the property and were observed in the aerial photograph. Plate 1A depicts the location of the landslides. Depth or character of the landslides is recommended to be investigated prior to development.

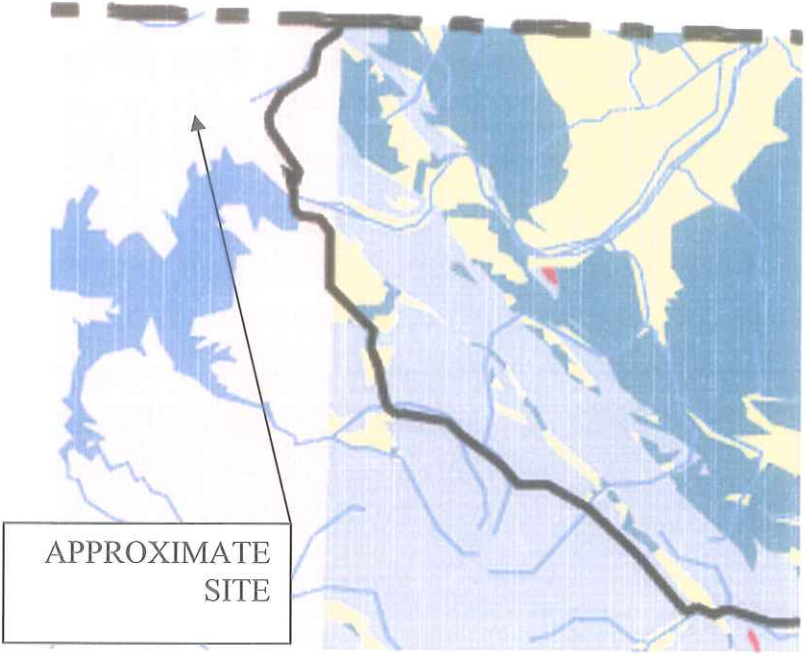
**LANDSLIDE HAZARDS MAP**  
COUNTY OF SAN LUIS OBISPO DEPARTMENT OF  
BUILDING AND PLANNING, 1999  
INTERLAKE ROAD, LAKE NACIMIENTO AREA  
SAN LUIS OBISPO COUNTY, CALIFORNIA

The San Luis Obispo County Safety Element maps the subject areas as no landslide data (Plate 10). Burch and Durham, 1970, Dibblee, 1971, Durham, 1974 and Dibblee, 1976 do not map landslides extending throughout or in the immediate vicinity of the site. Plate 9 presents an aerial photograph (Google). Multiple landslides were observed during geologic mapping of the property. Landslides are recommended to be investigated.
